# *The Great Flood of 1993*

## *Geologic Perspectives on the Flooding along the Mississippi River and Its Tributaries in Illinois*

March 1994  
Special Report 2

ILLINOIS STATE GEOLOGICAL SURVEY  
Morris W. Leighton, Chief

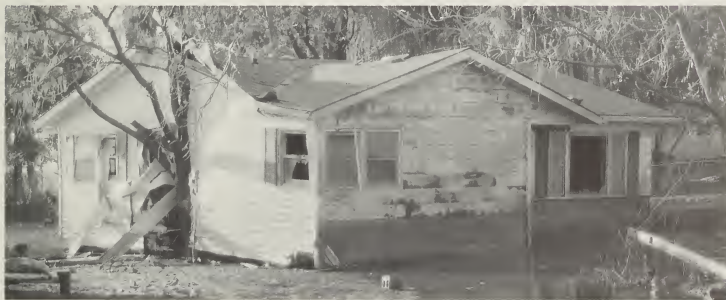
2 Monroe County: Flood water rushing through the town of Valmeyer lifted this house off its foundation and carried it until it collided with a tree (October 12, 1993).

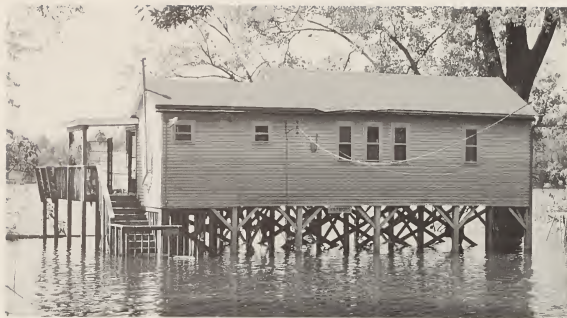
3 Adams County: High water came up to the windows of this house on stilts along the Mississippi River near Quincy. Oily film of silt and clay covers the lower half. Although the house stayed high and dry during other floods, it was not safe from the flooding in 1993, which exceeded the design height for flood protection (August 25, 1993).

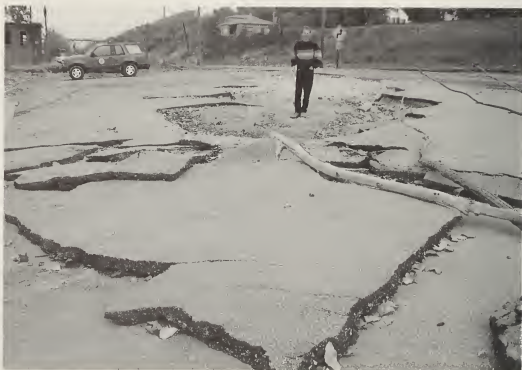
4 Randolph County: Asphalt pavement slabs next to the river-front road at Chester were lifted and transported by flood water. Robert Bauer, ISGS engineering geologist, stands where the blacktop slabs were eroded (October 13, 1993).

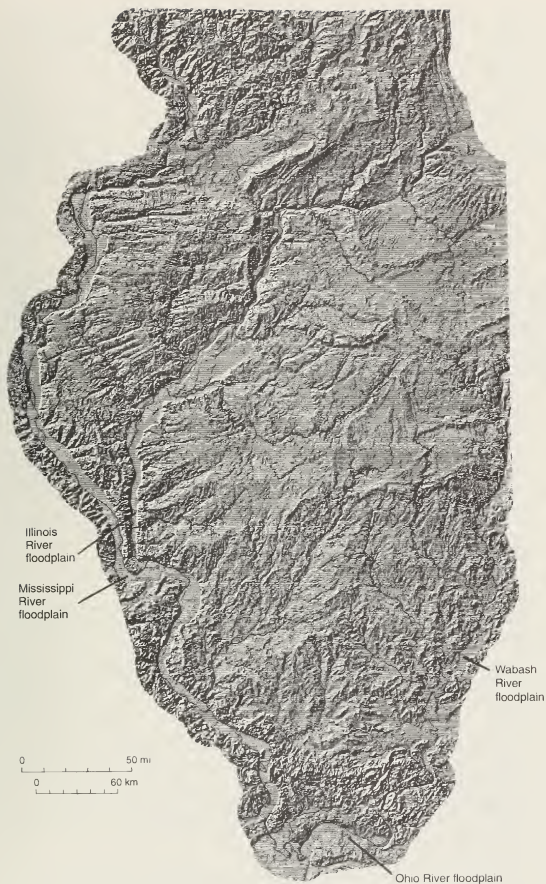
12 Shaded relief map of Illinois and parts of adjacent states. Nearly flat floodplains of the major rivers stand out in contrast to the variable relief of the uplands. (Computer-generated map from the Illinois Geographic Information System. Mapping derived from U.S. Geological Survey Digital Elevation Model data at 1:250,000 scale.)

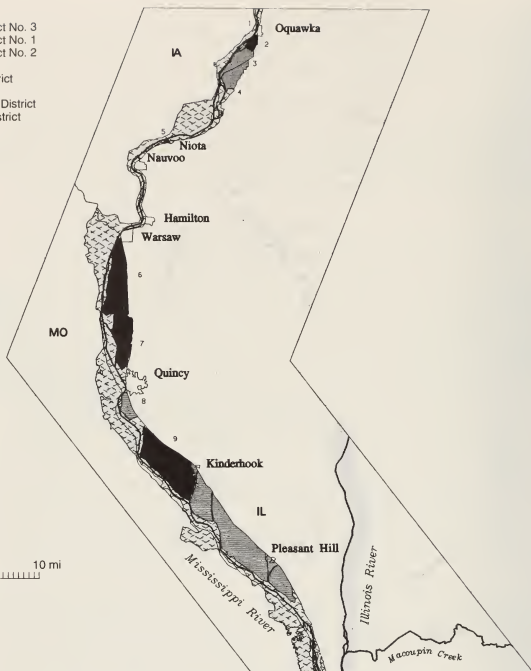
14 Floodplain and flood protection of the Illinois segment of the Mississippi River from about 4 miles north of Oquawka southward to about 25 miles south of Pleasant Hill.

Figures 13 to 16 show the extent of floodplains along the Illinois segment of the Mississippi River and the Illinois River south of Peoria. These maps also show how widespread the flooding was (its maximum areal extent) in 1993. Also shown are locations and names of drainage and levee districts and other flood-protection systems, and the drainage and levee districts flooded in 1993. A subsequent section on sediment types and distribution discusses how levees are constructed and how they can fail.

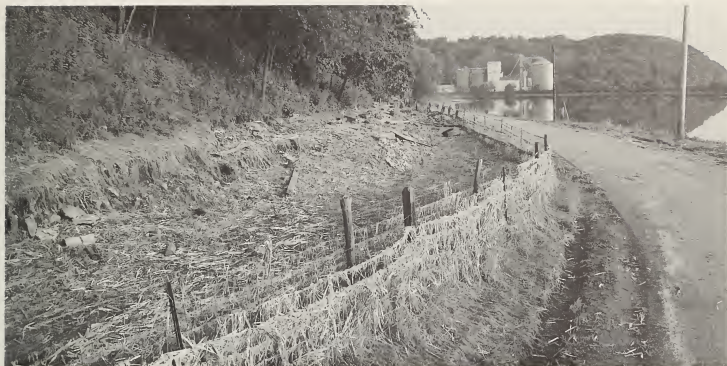
17 *Greene County: Dead vegetation (above) commonly marks high water line, as in this view of the Illinois river valley within the Hillview Drainage and Levee District. The town of Hillview is in the distance. Note the abundance of corn plant debris caught in the barbed-wire fence (August 25, 1993). Topographic map of Hillview and vicinity (left) shows configuration of the high water line. Spacing between contours relates to land slope. The widely spaced contours represent the relatively flat land of the floodplain. Closely spaced contours are the steep slopes of uplands and bluffs. Base map, Pearl East Quadrangle, USGS 7.5-minute topographic map, 1980.*

In any particular area along the flood margin, the surface elevation of flood water was uniform and defined a curving line of uniform elevation on the land surface (like the contours on a topographic map; fig. 17). As flood water receded, the high water line was well marked by the upper limit of dead vegetation, something like the ring left in a bathtub after the water drains out. Figure 17 shows the high water mark on a hillslope along the margin of the Illinois River valley. The extremely high water levels in this area caused flooding above the limits of the floodplain and up onto a bluff slope. The valleys and floodplains of tributary streams draining the uplands were low areas where flooding could extend even farther from the main river channel. The high water line in figure 17 goes around the hillslope and into the distant valley.

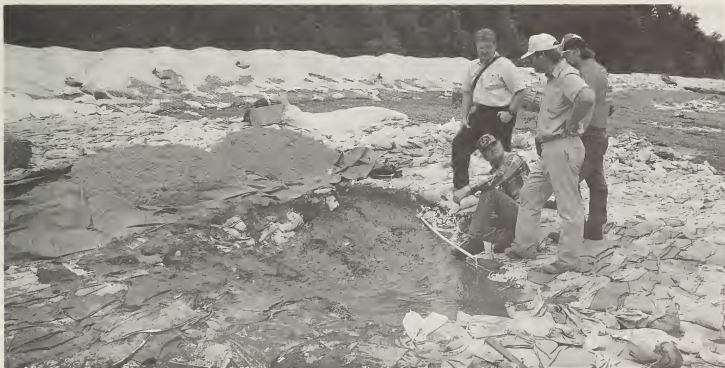
*24 Pike County: Water seepage caused piping of sandy material in the Sny Island levee, at about the place where it failed on July 25, near East Hannibal. The observers are engineers from the U.S. Army Corps and officials of the Sny Island Drainage and Levee District (July 21, 1993).*

Flood water on the river side of levees applies pressure to the levees, which are constructed to hold back water for a short time. Because of the unusually long duration of high water in the flood of 1993, water infiltrated permeable layers within and beneath the levees. The result was seeps piping sand out of the levee on exposed levee slopes. Along much of the Sny Island levee bordering the Mississippi River south of Quincy, seeps were a widespread problem, causing the levee to fail on July 25 (fig. 24).

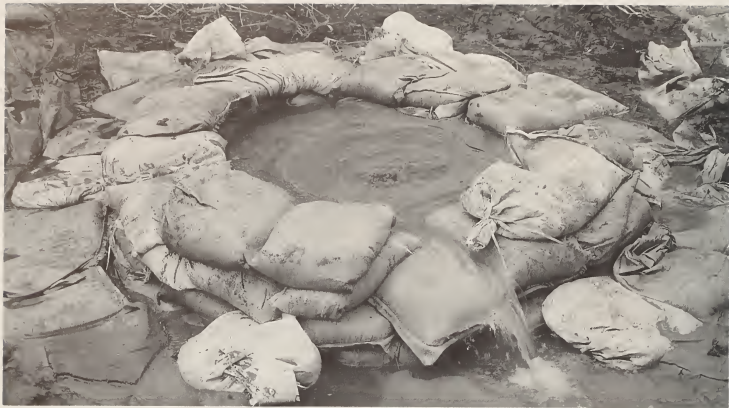
25 Pike County: Sand boil at the foot of the Sny Island levee. Sandbag ring dike prevents loss of piped sand but lets water flow away, reducing water pressure under the levee (July 21, 1993).

Sand boils were common on the floodplain adjacent to many levees. They formed where lenses of sand under or within a levee provided a pathway for water to pipe sediment. Unless piping (erosion) of sediment under or within the levee was halted, the flowing water would quickly sap the levee structure and cause a catastrophic failure. Sand boils were counteracted by building a dike of sandbags around the boil (fig. 25) and allowing water to rise within the ring. The rate of flowing water slowed within the ring dike, and the sandbags minimized the loss of sediment by trapping it in place and equalizing water pressure. Allowing the water to flow over the sandbag dike prevented water pressure from building up elsewhere in the levee. Sand boils can develop, then cease activity as changes occur in the flow pathways within the levee. Fine grained materials (silt or clay) transported within the levee may block the flow path and shut off one sand boil while opening a channel for another (fig. 26).

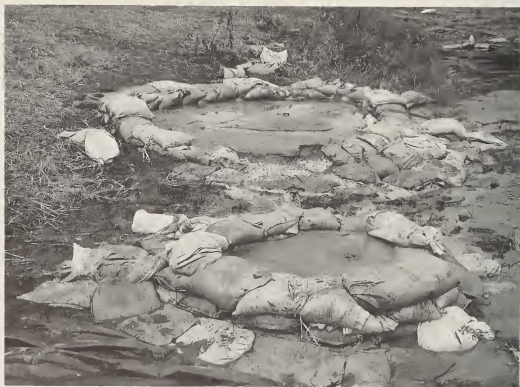
26 Active and inactive sand boils side by side at the foot of the Sny Island levee. Flow paths to the inactive boil (top) were possibly shut off by internal shifting of sediments (July 21, 1993).

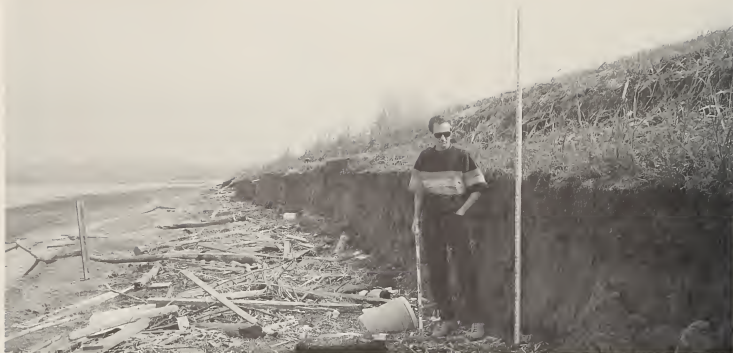
28 Randolph County: Nearly vertical cut made by waves eroding the inner (landward) side of the southern part of the Kaskaskia Island levee. Note the driftwood and debris where ISGS engineering geologist, Robert Bauer, stands at the base of the erosional cut (October 13, 1993).

In some areas, flood water of the Mississippi and Illinois Rivers submerged the floodplain from bluff to bluff. As a result, temporary lakes formed that were several miles wide (see cover photo). Waves on these lakes eroded the land along the high water lines. In many places, a wave-cut notch ranging from a few inches to 1 foot high was eroded along the high water line. Along bluff slopes, the erosion caused the soils overlying the notch to slump and undermined the foundation of trees and shrubs. Some farmers may face considerable expense in leveling their fields, but in general, the wave erosion had no major consequence. Remedial action will be required, however, along the inner side of the Kaskaskia Island levee, where an erosional cut nearly 5 feet high was formed by severe wave action (fig. 28). Apparently, the abundance of sandy materials in this section of the levee accelerated the wave erosion.

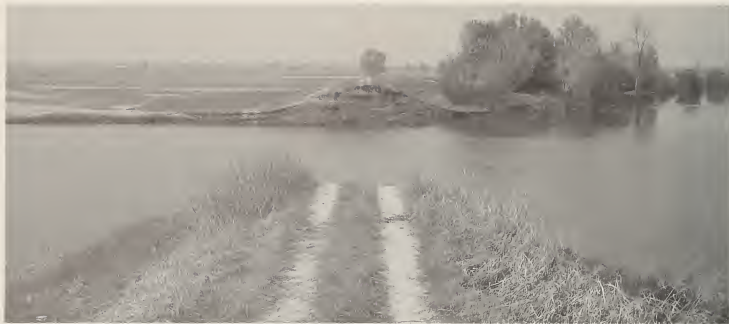
30 Randolph County: Looking northward across the levee breach in the Kaskaskia Island levee. (Figure 31 shows the depth of scour through this breach.) The Mississippi River channel is to the right beyond the range of the photo. (October 13, 1993).
